Accelerated Weathering of Overhead Loadbreak Switch Interrupters NEETRAC

Frank C. Lambert
Georgia Tech / NEETRAC

High Voltage Switch Subcommittee
Calgary, Alberta
October 15, 2008

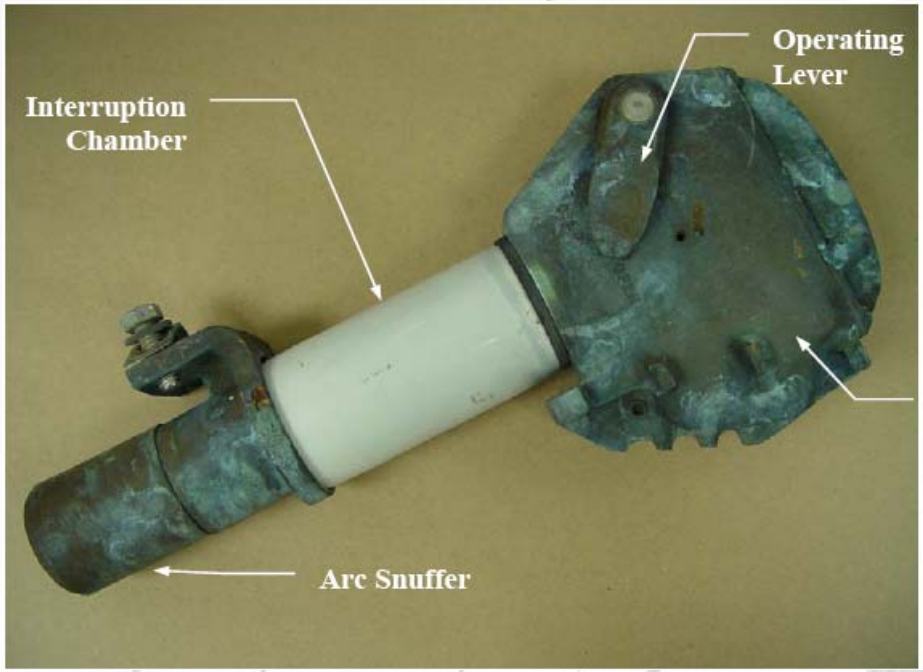
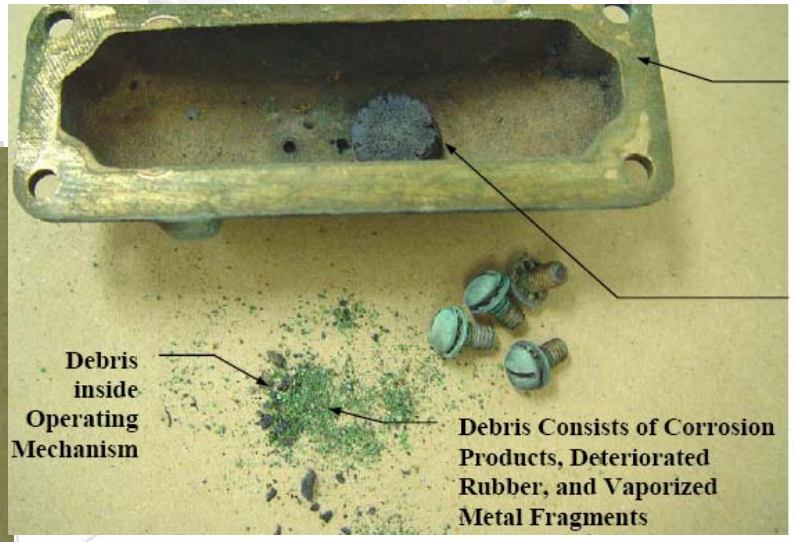
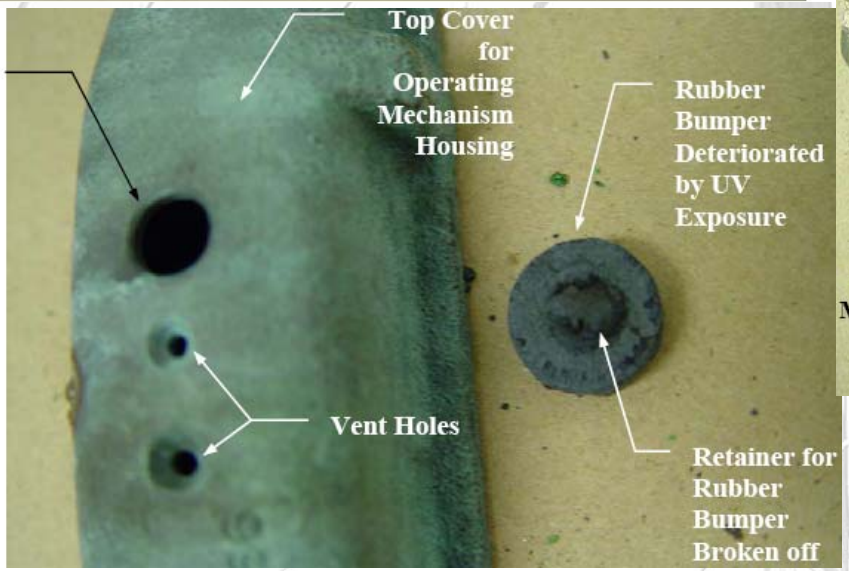
Returned from Field Service:
Alabama Power Company

- NEETRAC completed a scoping study to identify field problems with distribution loadbreak switch interrupters in 2005.
- Utilities reported problems with “stuck” interrupters or failures when opening.
- 17 loadbreak interrupters were removed from field service and returned to NEETRAC for evaluation.
- Many of the problems with these units appeared to be caused by UV deterioration and corrosion.
